Court case of a coupling flange of cast iron

Jan Spoormaker

Spoormaker Consultancy

Ruptured coupling flange

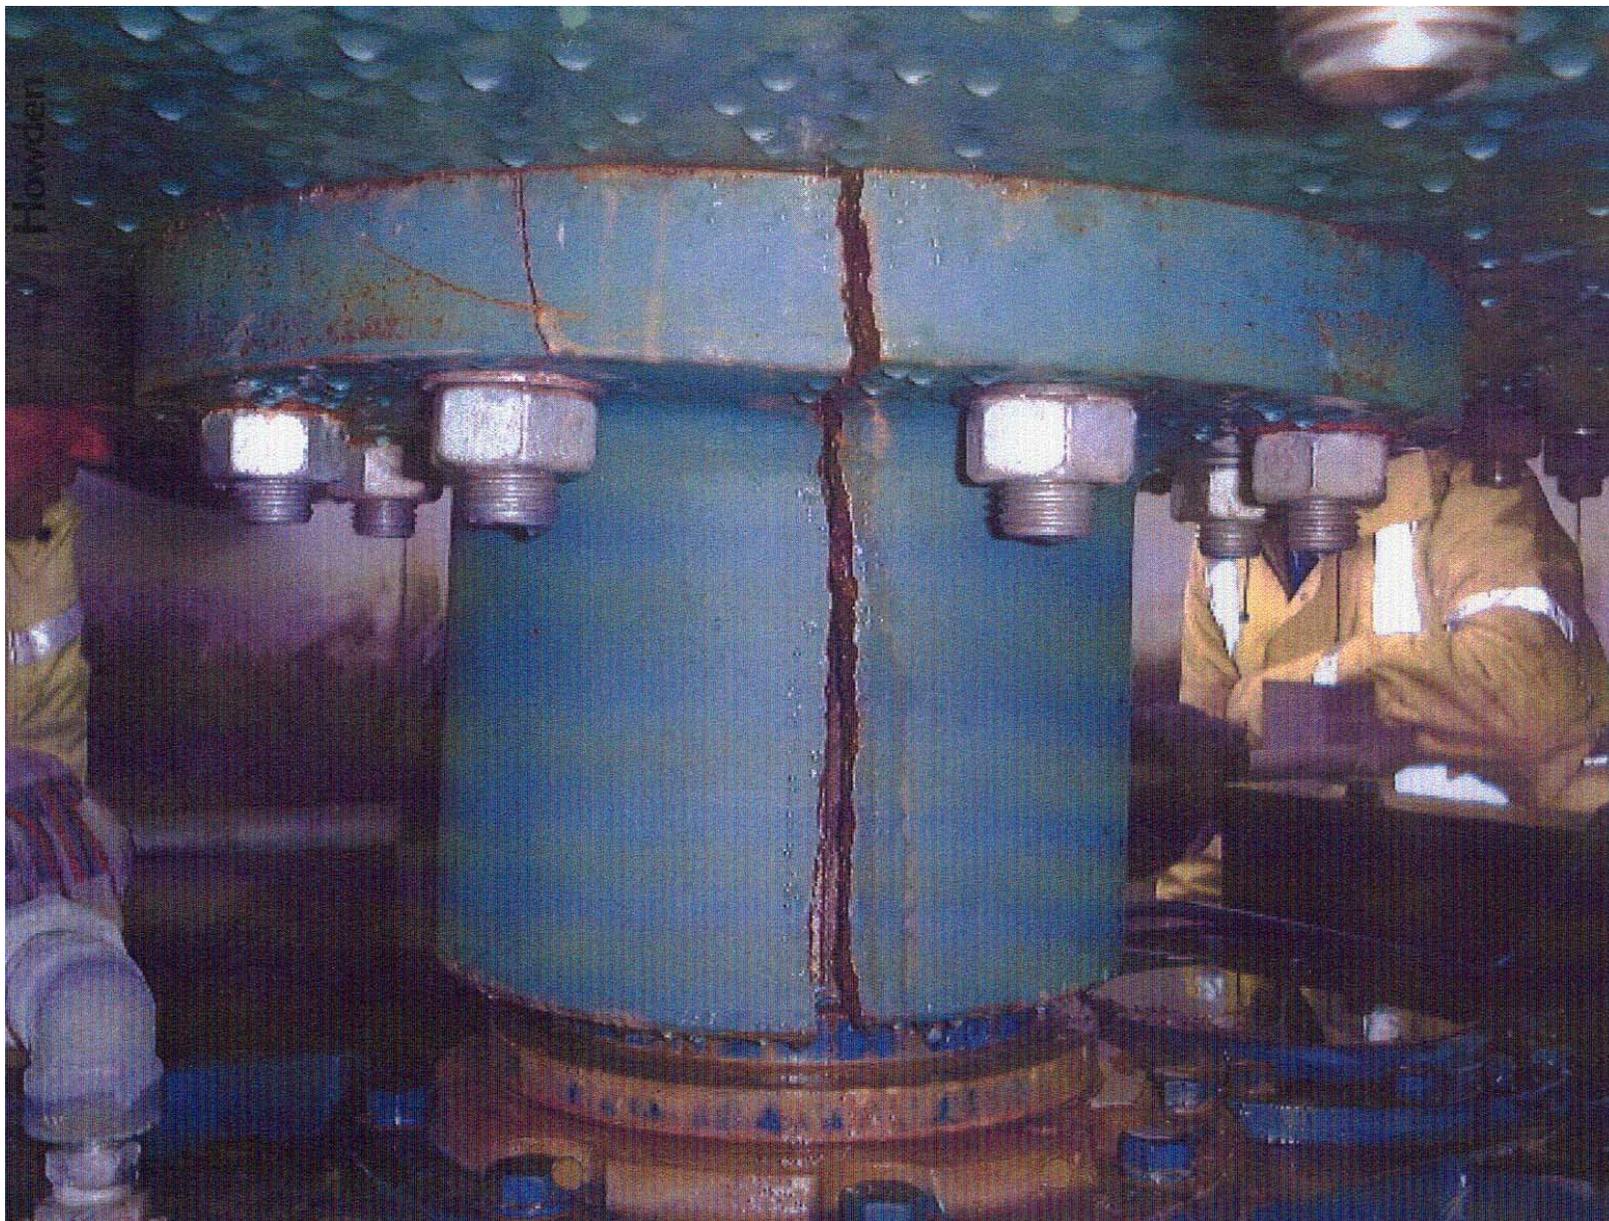
Ruptured coupling flange

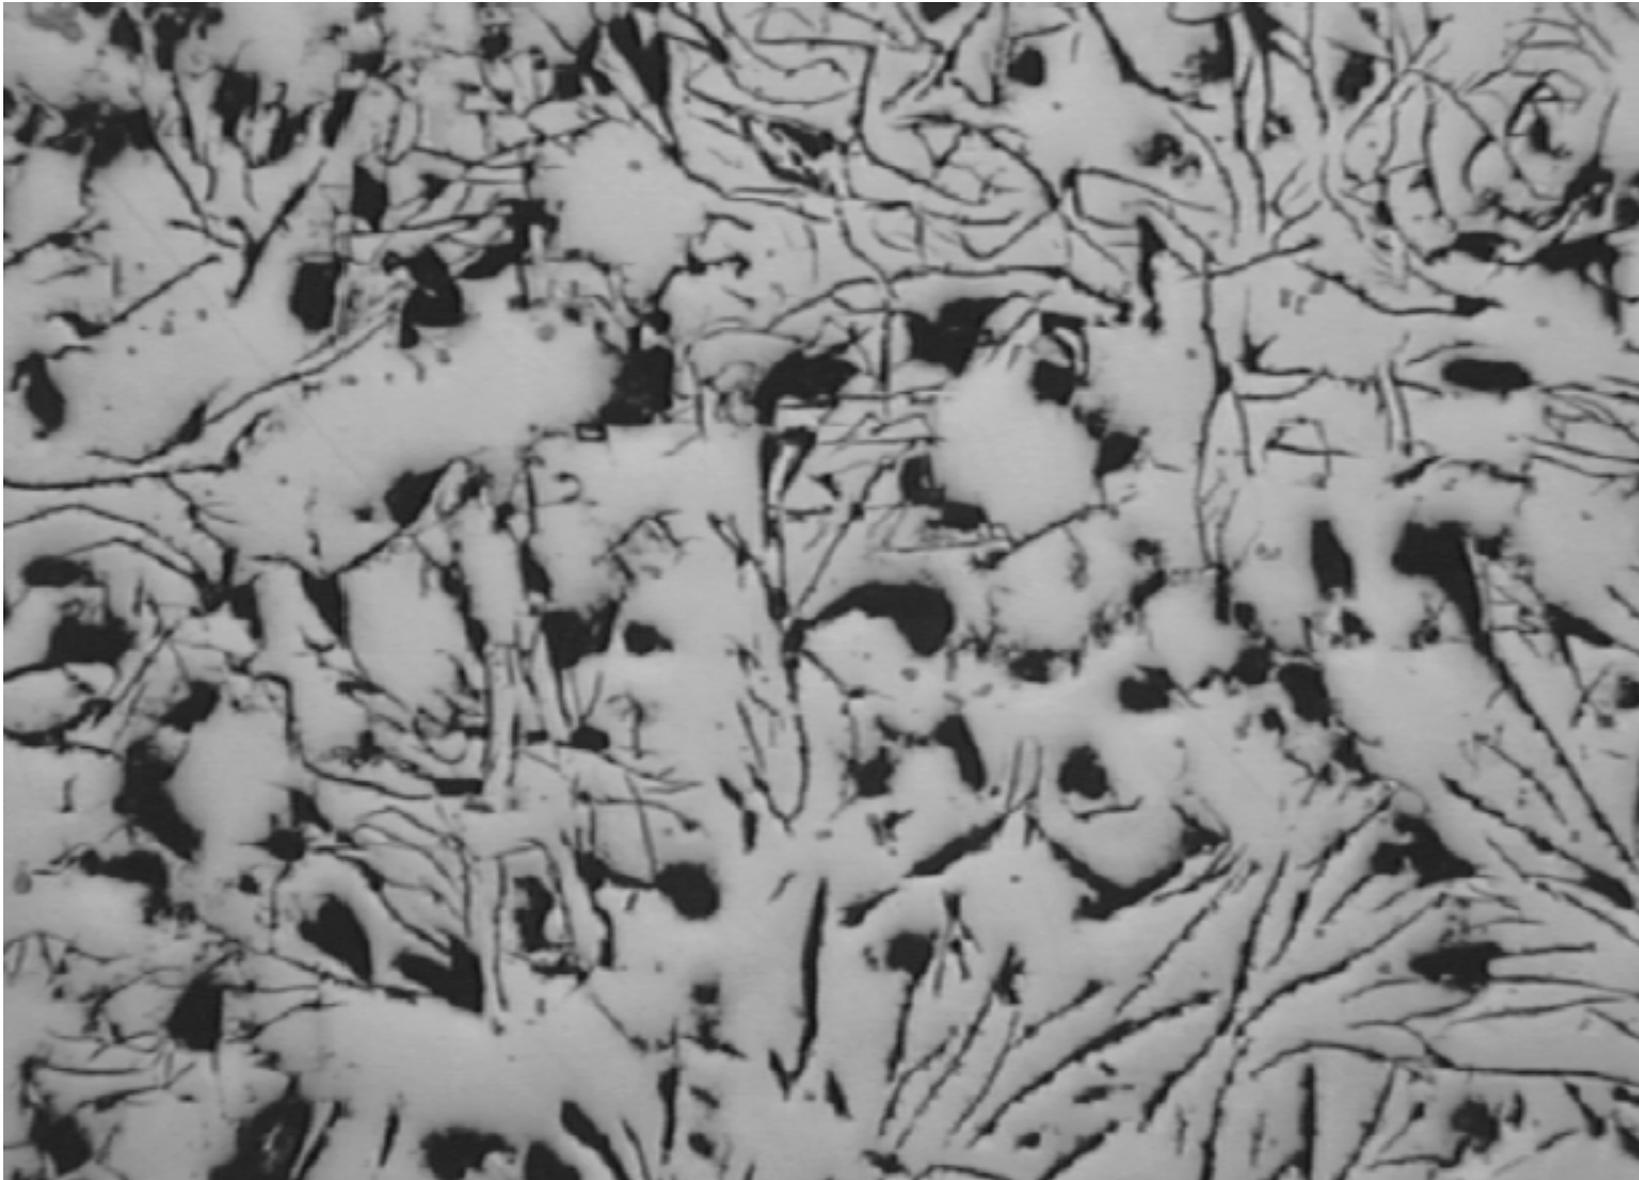
Microstructure of a bad flange

- *The cause of the low tensile strength is due to the degenerated microstructure. WTCM and Stork-FDO have determined this*
- *These microstructures occur in thick parts of mouldings, where the cooling rate is low. Small amounts of lead can also cause this microstructure.*
- *There was no evidence that the coupling flanges had been heated over **120 °C**. Stork-FDO has determined the microstructure over the whole cross section and this was constant.*
- *Only if the flanges had been heated over 200 °C by a gas flame*

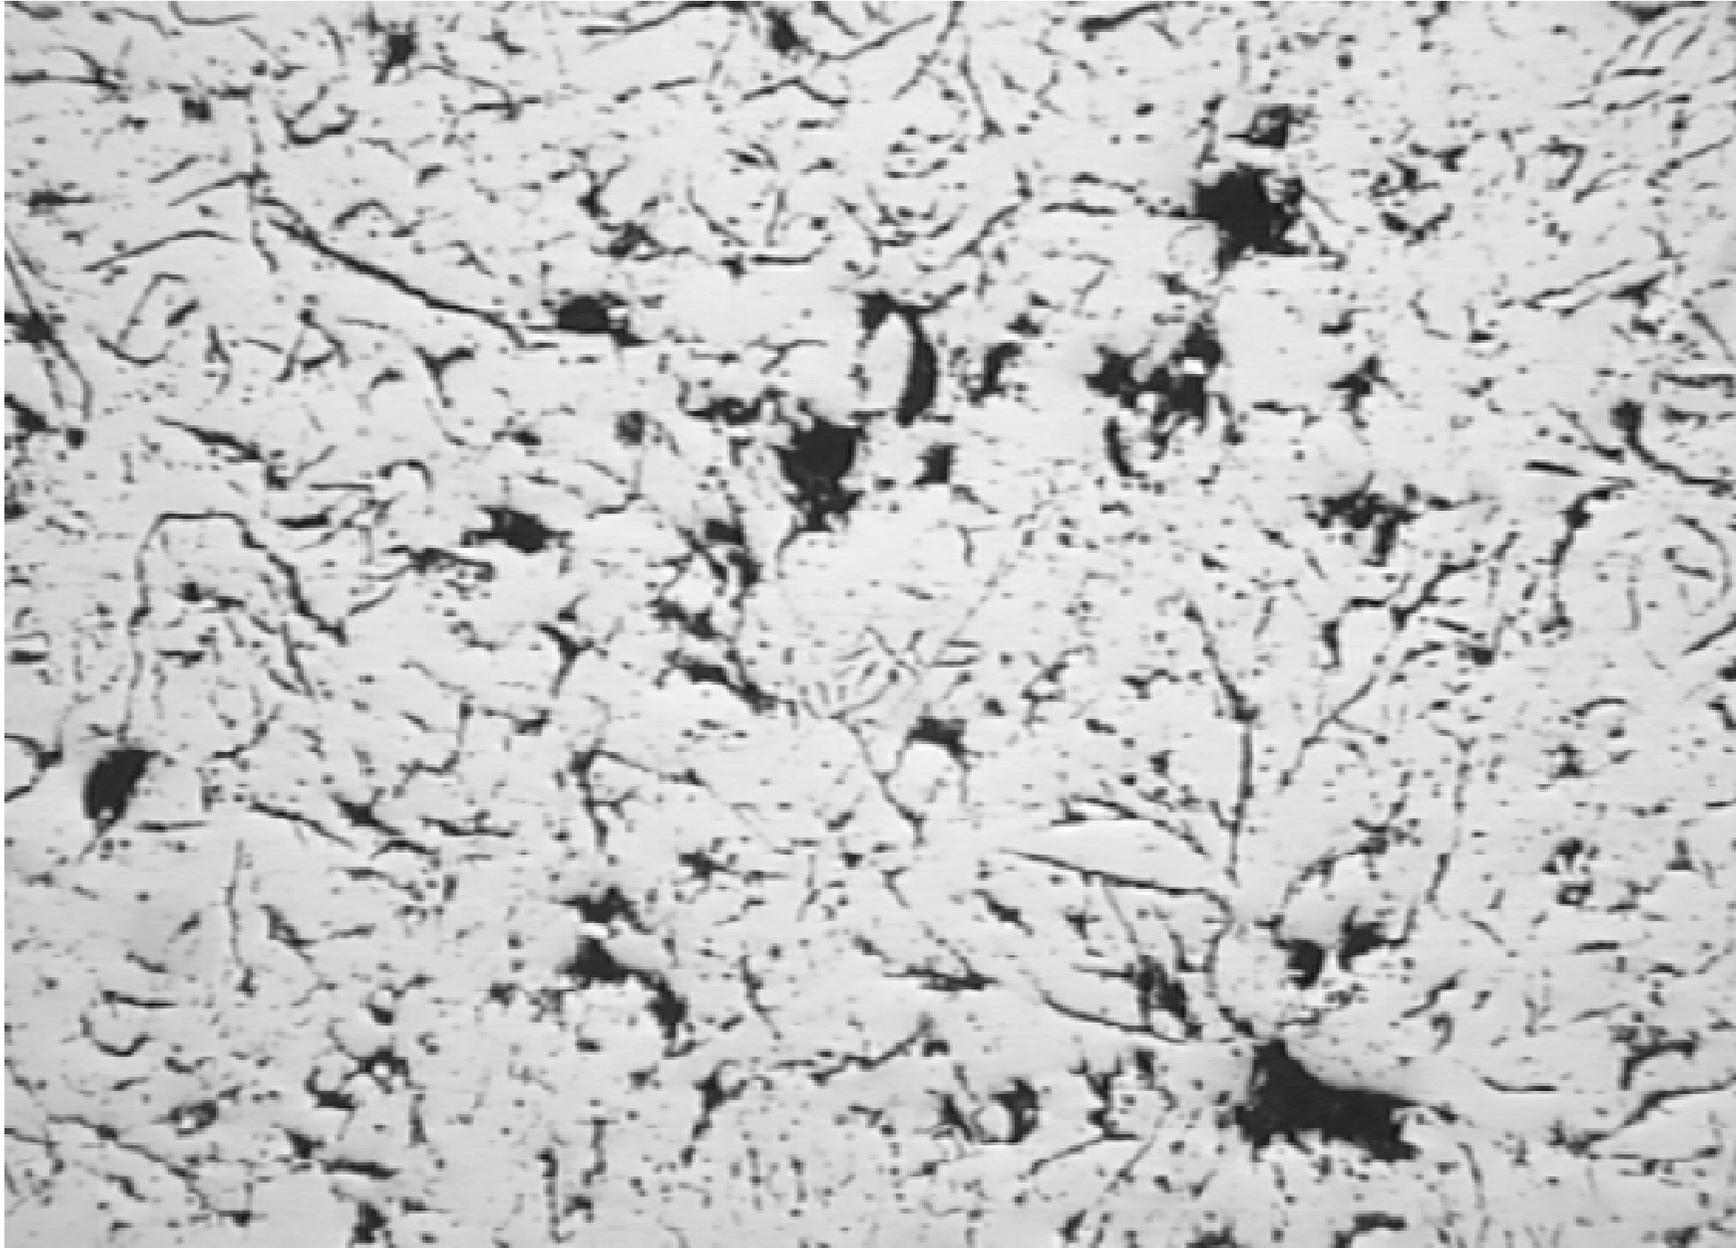
Microstructure of another bad flange

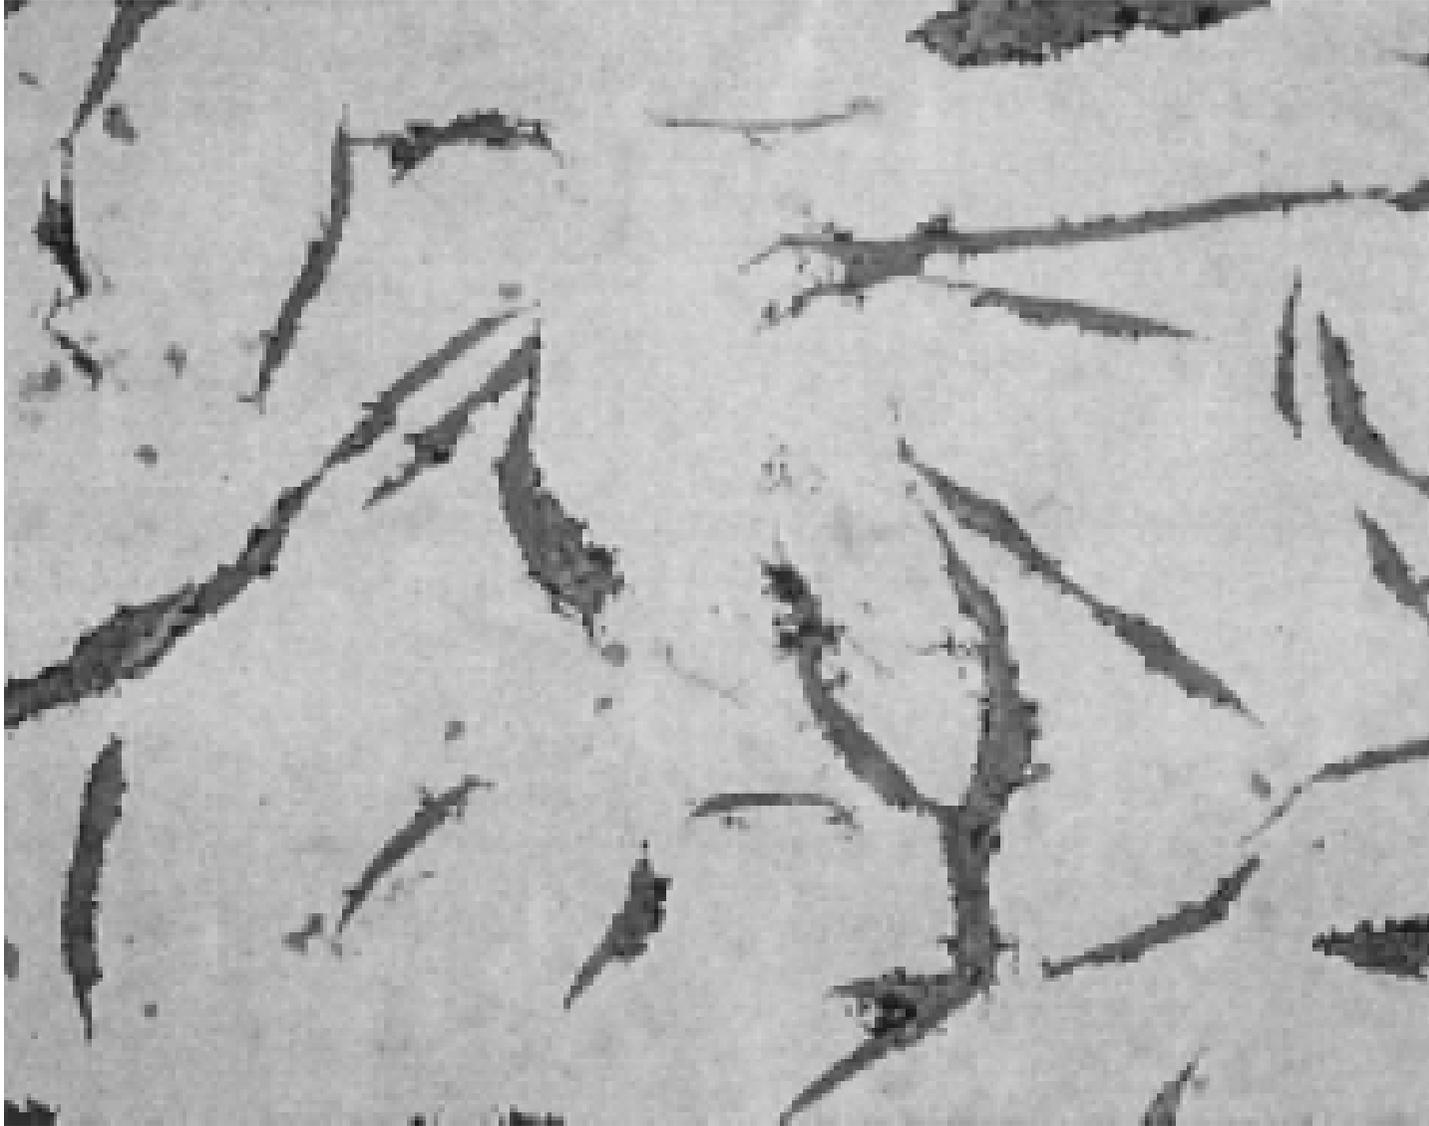
Graphite appears “fuzzy” and other graphite forms have precipitated within regions between flakes; (400X, unetched condition).

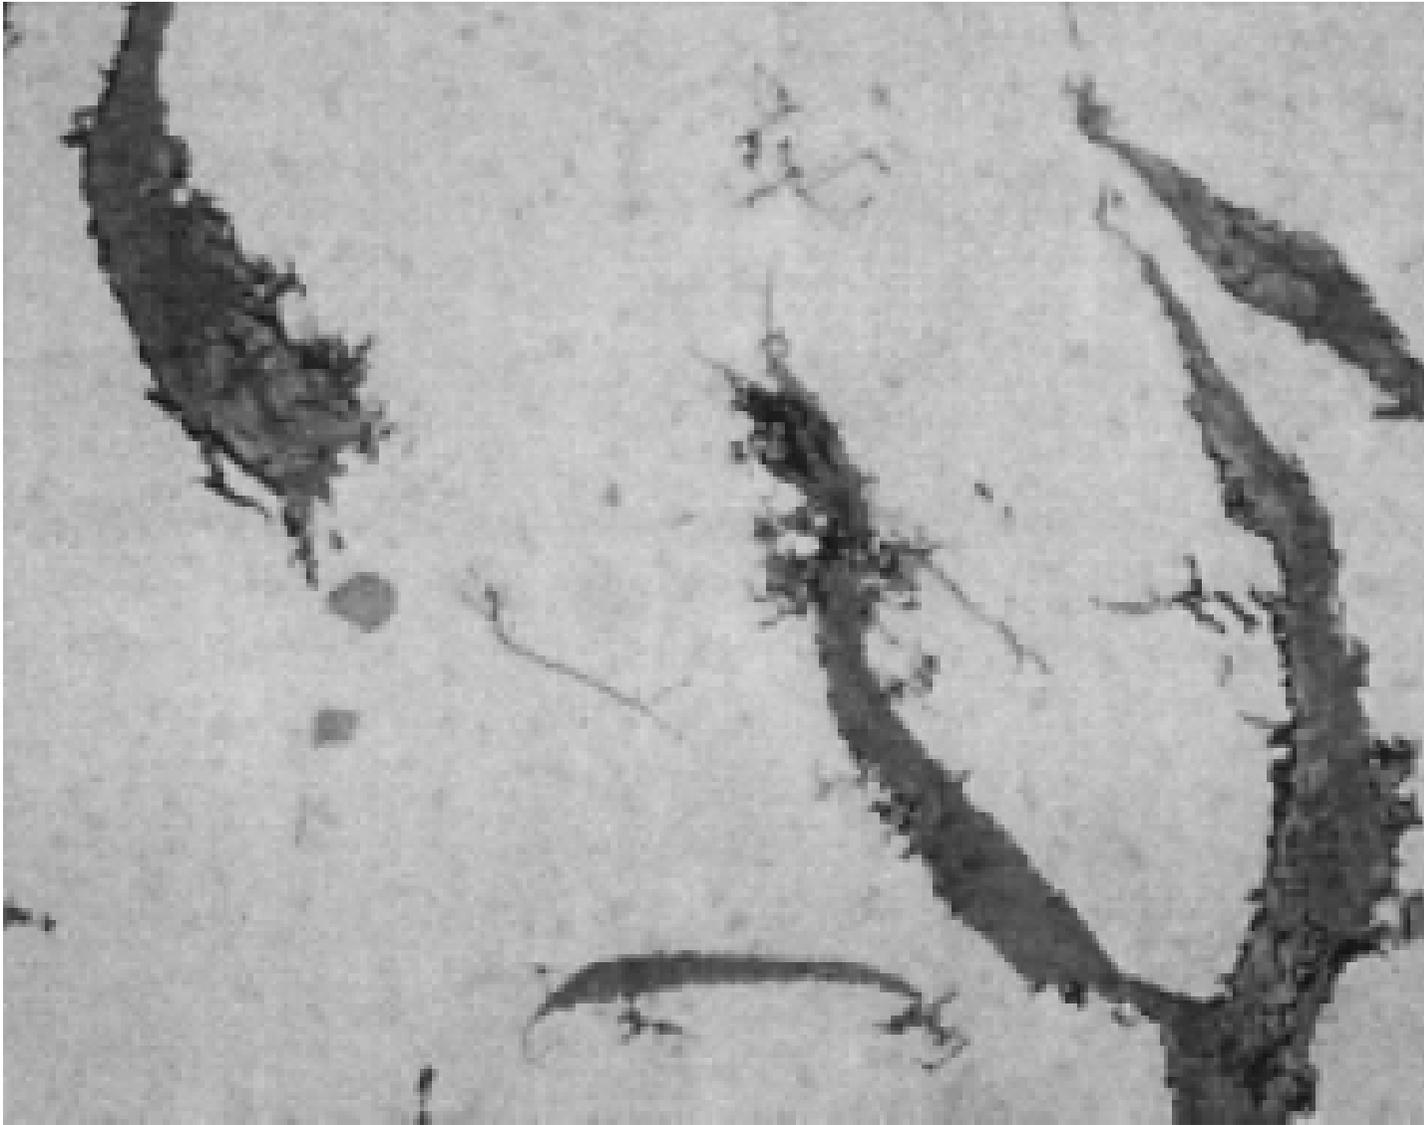
“fuzzy” graphite is consequence of small fingers of graphite growing on sides of graphite flakes. Also note graphite forms with thin graphite forms in between graphite flakes toward middle and middle top; (1000X, unetched condition).

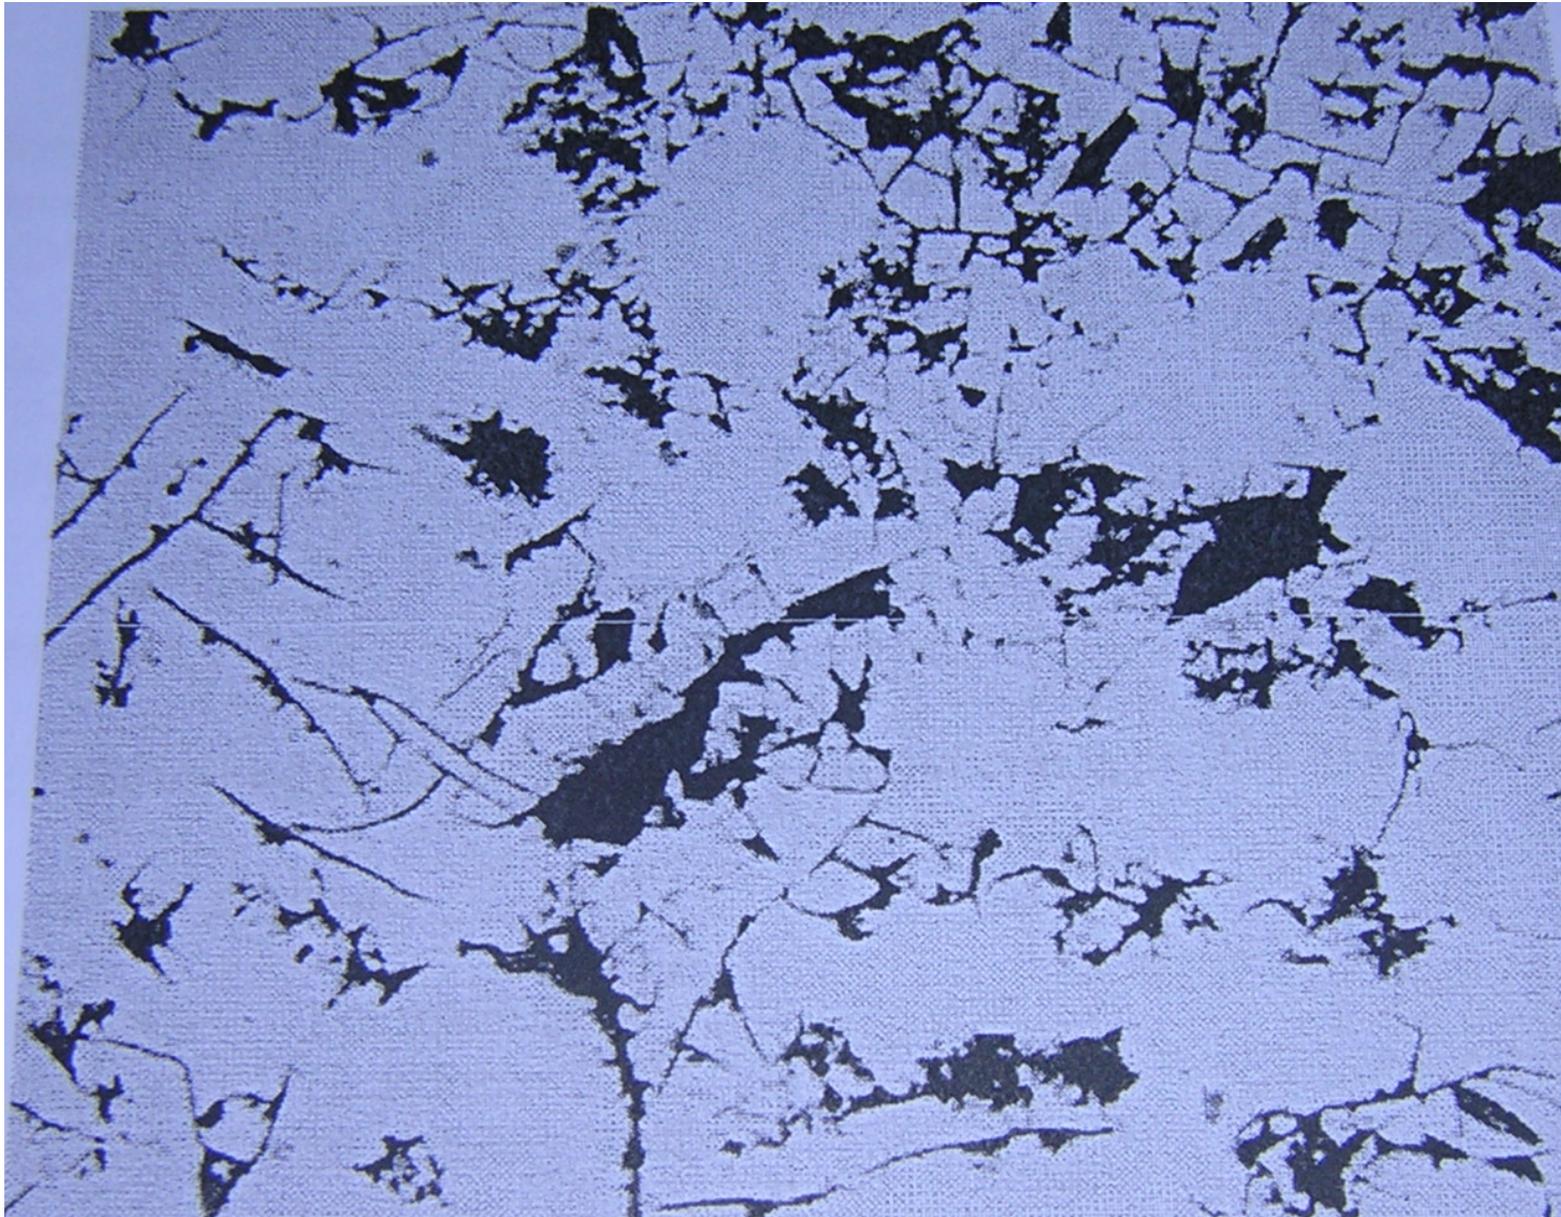
Photograph of microstructure determined by WTCM
